JFK AIRPORT PEDESTRIAN TUNNEL

New York, New York, USA
Spring 2004

CONCRETE
WATERPROOFING

PROJECT CASE STUDY

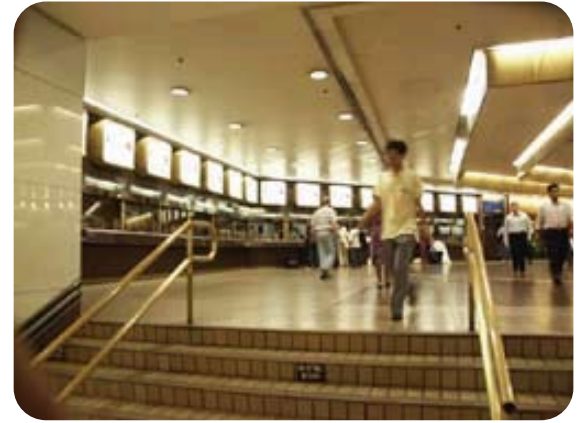
Part of the terminal construction involved building a new 1,500-foot-long, 150-foot-wide concrete pedestrian tunnel, which runs 25 feet below finished grade with a water height of 12 feet at high tide.

Once the 50-foot test repair proved watertight, the project team gave the go ahead for full repairs to begin. The repair team began by grinding out the cracks and joints to remove the epoxy and other materials that had been used in an attempt to stop the leakage. Honeycombed sections where air had not entrained properly were also chipped out. The Krystol™ T1/T2 system was applied on all cracks and joints successfully. Even cracks greater than .75 mm were able to self-seal when allowed adequate time for crystal growth to occur.

After the shrinkage cracks and cold and construction joints were repaired, the Crystal Group used Krystol™ T1/T2 to repair a shifting armour joint, which connected two 500-foot concrete tunnel sections. The 87 feet of repairs were made more difficult by freezing temperatures and a continuous flow of 40-degree ground water at 15 PSI. Furthermore, the JFK project team wanted to pressure-test the repairs just 7 days after completion, which is earlier than recommended. Despite the adverse conditions and shortened timeframe, the test was successful and the armour joint proved watertight.
