ANNACIS ISLAND WASTEWATER PLANT

CONCRETE
WATERPROOFING

PROJECT CASE STUDY

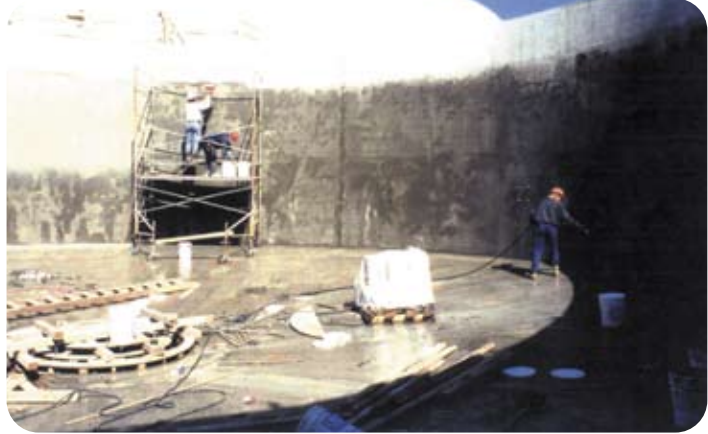
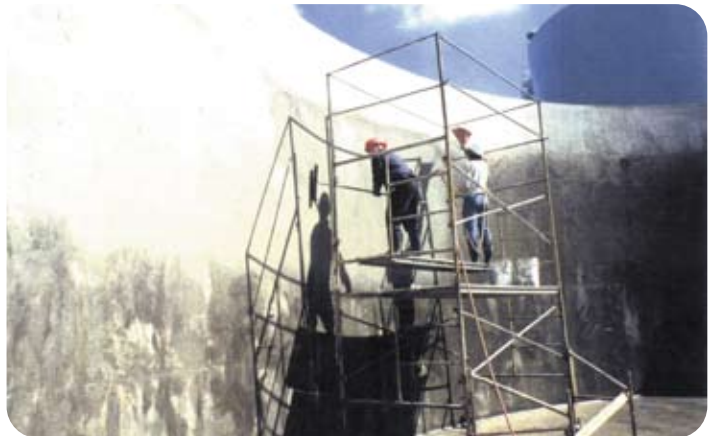
Initial construction of four huge DAFT tanks, several meters in height and 400 millimeters thick, did not utilize Kryton's KIM™ admixture. Severe cracking and leaking resulted, especially at the tapered tie holes and cracked locations. Subsequent ground settling contributed to the poor performance by creating new cracks. Some voids were full depth and as much as 400 mm in diameter. In 1996, Kryton International was consulted and contracted to provide Krystol™ materials to repair the leaking tanks and other walls at the facilities.

Krystol™ Baricote was used to repair the tapered tie holes. Krystol™ T1 and T2 were applied to the inside surfaces of the tanks. Subsequent inspections over several years after the Krystol treatment was applied showed that many cracks continued to develop in the huge tanks. However, the cracks quickly self-healed and did not leak. The Krystol materials continue to perform beyond expectation.
