# YESLER BUILDING BASEMENT REPAIR

WASHINGTON, USA

**CONCRETE  
WATERPROOFING**

PROJECT CASE STUDY

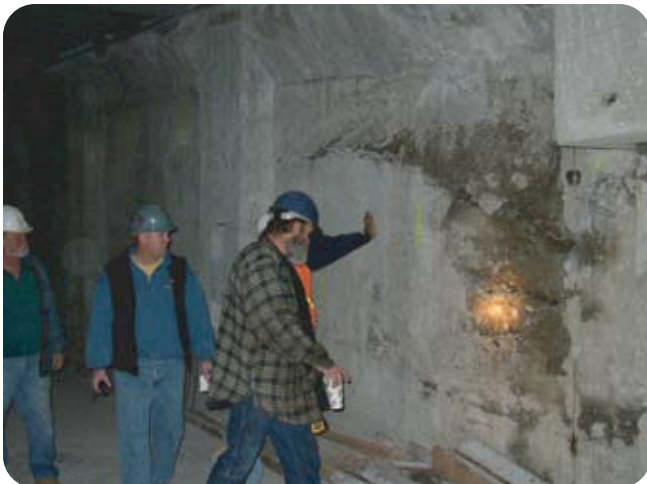
Over the years, moisture and repeated freezing and thawing had caused the building's porous concrete to deteriorate, leaving gaping holes in walls and corroding steel reinforcements. In the building's 2-level basement, damage was so severe that these floors had essentially been abandoned. Moisture and mold had created a musty smell and the building's wiring had begun shorting out due to water leakage in the electrical system.

*Left: Holes in the wall before the repair.*

A test section of the basement was repaired using Krystol™ T1/T2, a cementitious brush-applied product suitable for waterproofing existing concrete, in an application known as Krystol Specification 1. Satisfied with the results in the test area, the county authorized repairs in the entire basement using Krystol Specifications 1 and 2 and various products from the Krystol™ Concrete Waterproofing Line. One inside wall was so badly damaged that, once the holes had been grouted in, a rebar grid was built and Krystol-treated shotcrete was used to form a new wall.

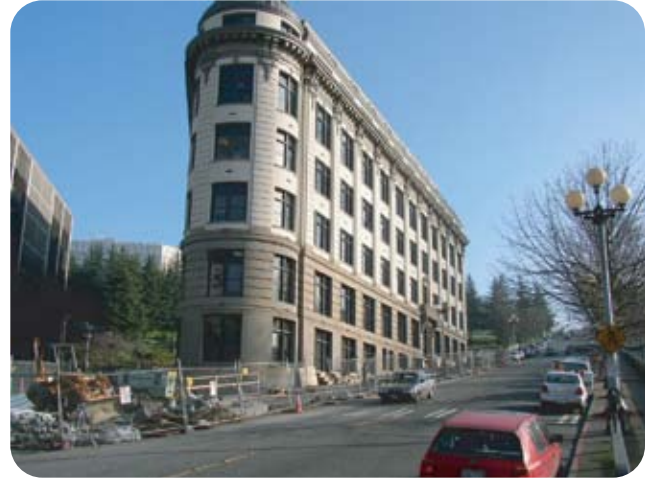
*Right: After the T1 System Repair.*

Given the extent of the original damage, it wasn't surprising that, once the first round of repairs was complete, water continued to seep through the concrete in a handful of areas. When cracks and leaks are repaired, water will sometimes find other weaker areas in which to seep through. Once these "weepee" spots in the concrete were identified, they too were repaired using Krystol™ T1/T2.

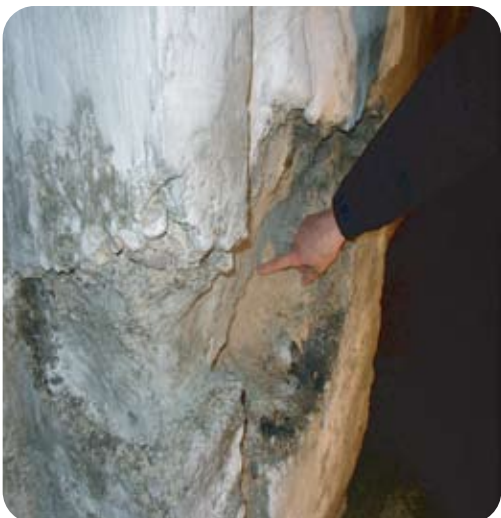
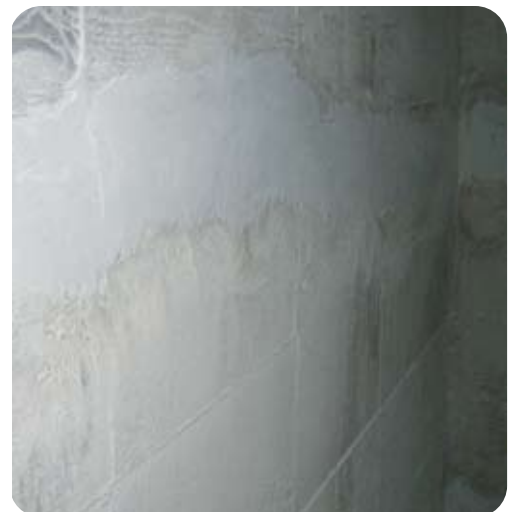
Before and After shots.

*Left: Holes in the wall before the repair.*

*Right: After the T1 System Repair.*

A test section of the basement was repaired using Krystol™ T1/T2, a cementitious brush-applied product suitable for waterproofing existing concrete, in an application known as Krystol Specification 1. Satisfied with the results in the test area, the county authorized repairs in the entire basement using Krystol Specifications 1 and 2 and various products from the Krystol™ Concrete Waterproofing Line. One inside wall was so badly damaged that, once the holes had been grouted in, a rebar grid was built and Krystol-treated shotcrete was used to form a new wall.

Given the extent of the original damage, it wasn't surprising that, once the first round of repairs was complete, water continued to seep through the concrete in a handful of areas. When cracks and leaks are repaired, water will sometimes find other weaker areas in which to seep through. Once these "weepee" spots in the concrete were identified, they too were repaired using Krystol™ T1/T2.
