RESIDENTIAL SWIMMING POOL DUBAI, UNITED ARAB EMIRATES

**CONCRETE
WATERPROOFING**

PROJECT CASE STUDY

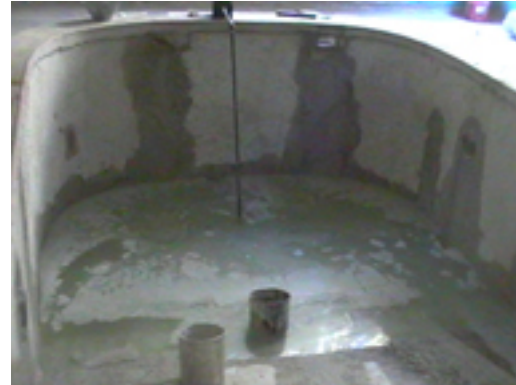
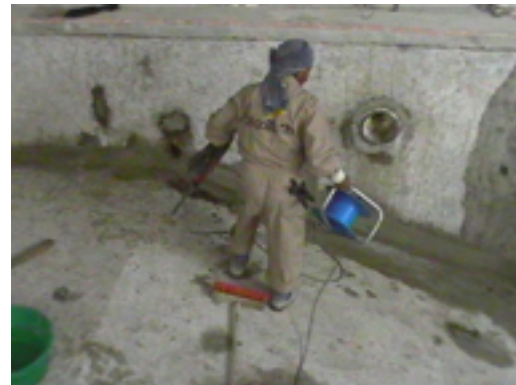
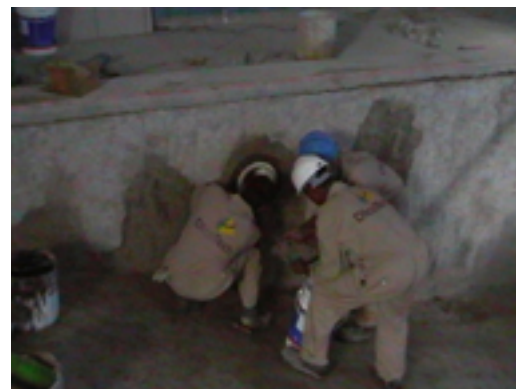
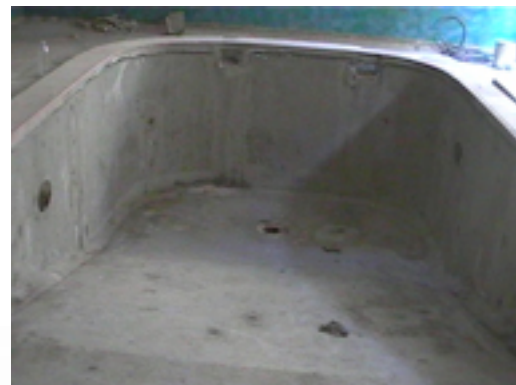
A villa swimming pool in Mamzar (Dubai) required a waterproofing system that would stop severe leakage due to tremendous hydrostatic pressure.

All the leakage points were treated and repaired one by one utilizing Krystol Crack repair system to stop the flowing water as shown. The leakage points continued to shift during the repair treatment due to high hydrostatic pressure

In November 2003, GST was contracted to supply the materials to stop the severe leakage and apply waterproofing to the concrete. The Krystol Crack repair system was first utilized to stop the flowing water from many points and then the Krystol T1 and T2 brush on system was applied on the entire concrete surface.

The water leakage from all the leaking points was totally stopped after 12 days. Unlike previous attempts with the other materials, the Kryton system worked as specified to stop the leaking water. To date the system is performing as specified.
