Seton Power Canal & Aqueduct Repairs

Lillooet, Canada (2010)

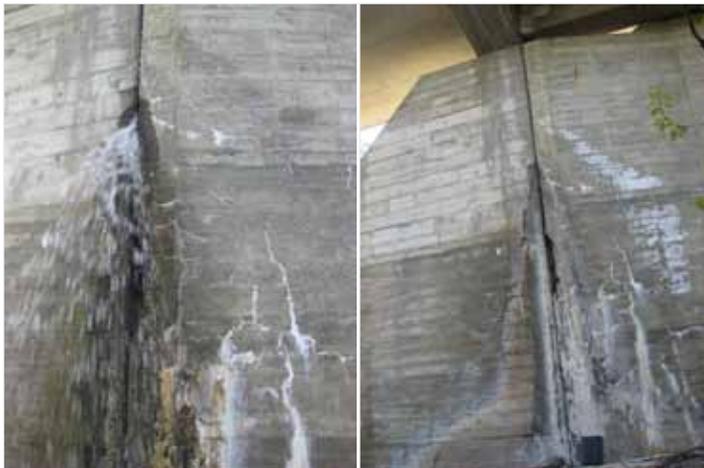
Aqueduct over Cayoosh Creek – water was pouring out of the crack before the dewatering occurred.

The walls and floor of the canal were pressure washed in sections, cracks and spalls were repaired, and the surfaces were coated using Kryton's Krystol Crack Repair System and Surface Treatment System. In total, over 11,000 kg of Kryton's repair products were used to restore and waterproof the massive concrete structure. The repairs were completed in Spring of 2010 and 2011.

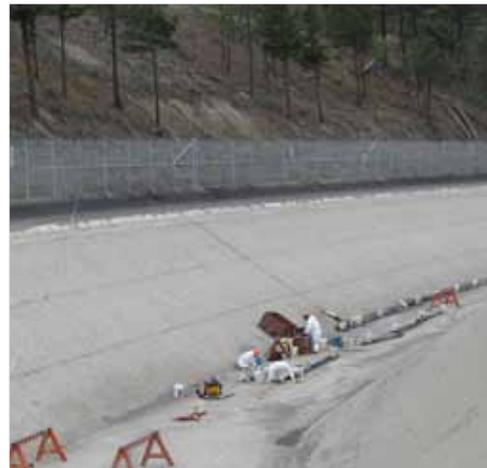
Workers performing concrete repairs with Kryton products to portions of the canal's walls and floor.
