Liwa Centre Apartments - Repair

Abu Dhabi, United Arab Emirates
2010

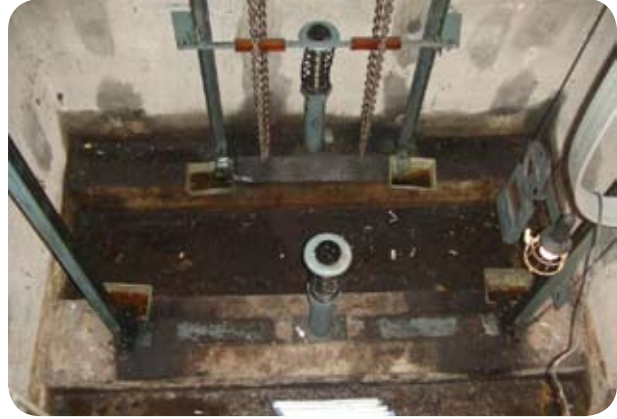
The area faces significant ground water pressure. Due to the high hydrostatic pressure several leaks in the elevator pits appeared after construction. At best, the cracks are just an unattractive nuisance but at worst, they lead to leaks that can damage the interior of the building, corrode steel reinforcements and ultimately shorten the life of the building. Several attempts to repair the leaks using different materials proved unsuccessful.

High hydrostatic pressure caused leaks in the elevator lift pit.

After several attempts to repair the leaking elevator pits the management team decided to try Kryton's Krystol Crack Repair System.

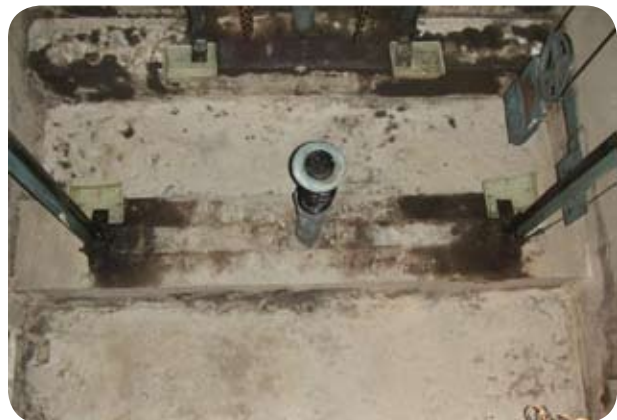
To date the Krystol Crack Repair System has stopped the leaks in the elevator pit.

The Krystol Crack Repair System stopped the leaks

The Krystol Crack Repair System was successful where previous systems had failed. The Krystol Crack Repair System is different from other systems it:

- protects from any direction – even against high water pressure
- can be applied to either side of the concrete (eliminating the need for perimeter digging)
- protects reinforcing steel against corrosion
