# Oakland Zoo Tiger Pool

Oakland, USA (2011)

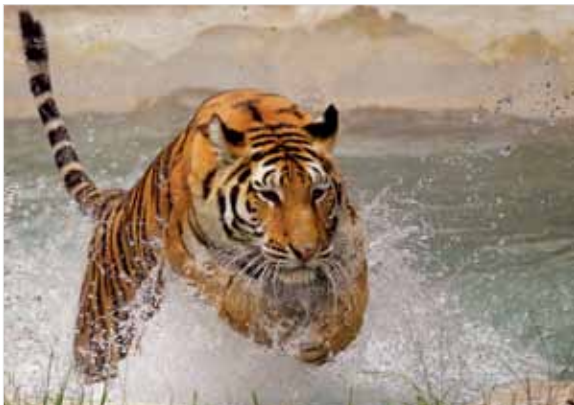
*The Oakland Zoo tigers can now enjoy their repaired pool.*

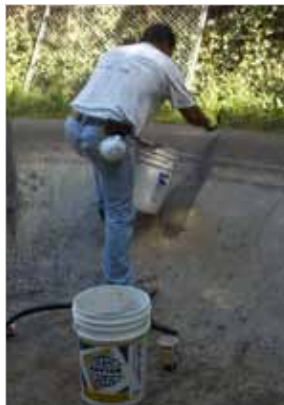
*Filling cracks on the tiger pool.*

The cracks were filled with Kryton's Krystol Bari-Cote and Krystol T1. Then the whole pool received a coating of Krystol T1 and Krystol T2 waterproofing treatment. After a week the pool was filled and ready for the tigers to enjoy!
