# The Mall, Gadong

Brunei Darussalam (2010)

## BACKGROUND

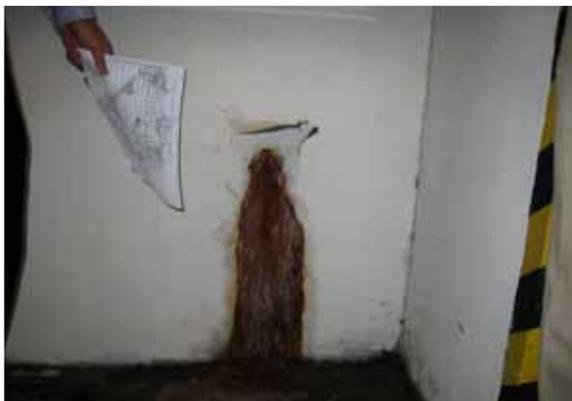
The mall was completed in 2004 using a membrane system to address their concrete waterproofing. After less than three years of service several leaks were discovered including the second level of the basement car park.

*Just one of the several leaks that The Mall owners were unable to repair using epoxy and other repair systems.*

After several other waterproofing repair attempts the contractor contacted BUE Enterprise, the local Kryton distributor to try out a repair using the Krystol Crack Repair System. The trial was at two of the most challenging areas where other repair systems had previously failed.

BUE Enterprises was successful in stopping the leaks. The contractor was happy to finally have a solution and invited BUE back to complete the repairs on the other leaking areas.

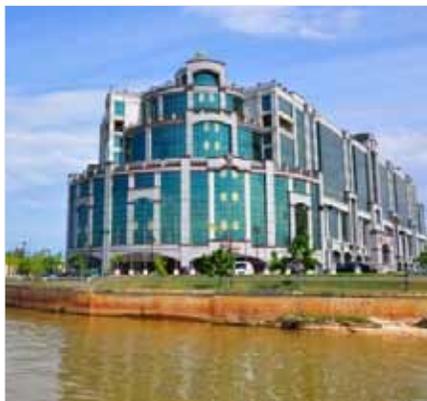
*The unique looking mall sits right on a river bank and is subjected to hydrostatic pressure.*
