# Sealord FV Rehua

Main Freezer Floor, New Zealand (2012)

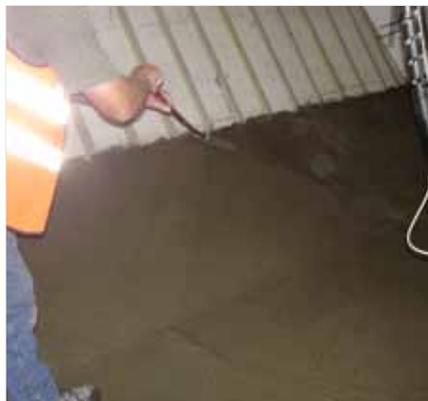
*Brush applying Krystol T1 and T2 to the freezer floor.*

The floor was prepared by grinding, removing sealant from the joints and then washing to remove any oils etc. The surface was then brought to SSD condition and the first coat of T1 was applied. Due to the location at the bottom of the ship there was not a lot of air movement so a fan was used to move the air around in the hold overnight to harden the T1 layer without it drying it out too fast.

This was repeated with two coats of T2. Wet curing was done over three days and then the surface was left to harden before the ship set sail.

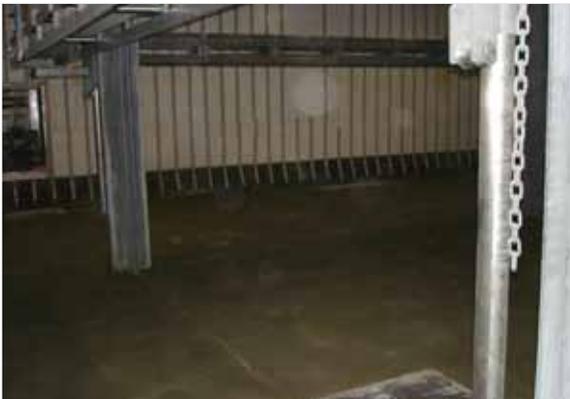
***The completed freezer floor.***

The application and curing process took just over a week; and over 825 m<sup>2</sup> (8,800 ft.<sup>2</sup>) were coated with three coats of Kryton's Krystol T1 & T2 Waterproofing System.

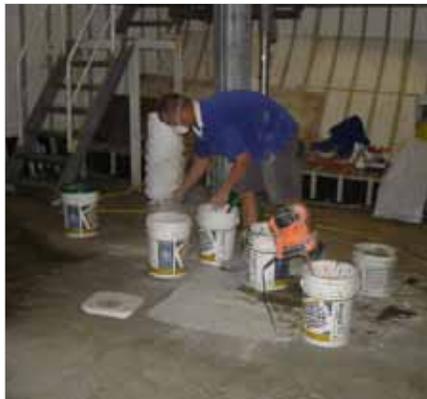
***Mixing Kryton products for the job.***
