Pacific Coast Terminals' Tunnel Repairs

Port Moody, BC, Canada (2017)

Pacific Coast Terminals Co. Ltd.

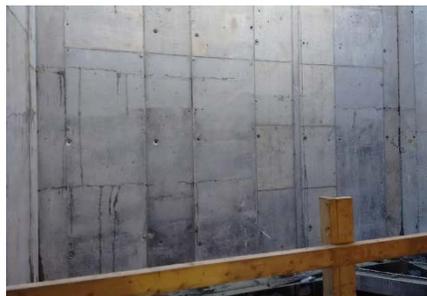
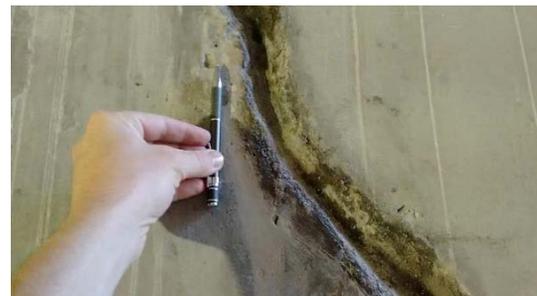
Of course, that level of trade is only possible when everything runs smoothly. Part of that means keeping transportation routes safe and viable, which by the mid-2010s was threatened when three of PCT's concrete conveyance tunnels started cracking and leaking. While they had been given waterproofing protection during their construction, it had not been effectively applied in a way that would prevent such water infiltration.

Under their guidance, the contractor teams chiseled a 25.4-millimeter (one-inch) chase across the entire length of each crack. That made room for the leak repair system's Krytol Plug solution, which the contractor teams chose to apply to the entire chase.

Due to its rapid-setting cement nature, Krystol Plug hardened within a couple minutes, creating a barrier that could stop the infiltration of water no matter the hydrostatic pressure. It was perfect for getting the leaking under control and giving the contractor teams time to add the leak repair system's Krystol Repair Grout.

Before applying it, Kryton's tech expert recommended that the teams use a wire brush to flatten the plug application and remove any of it from the sides of the chase. That would leave room for the grout and allow it to bond to the concrete sides of the chase, giving it the best chance to employ its advanced fiber technology and shrinkage-controlling additives, which would both help prevent the concrete from cracking further.

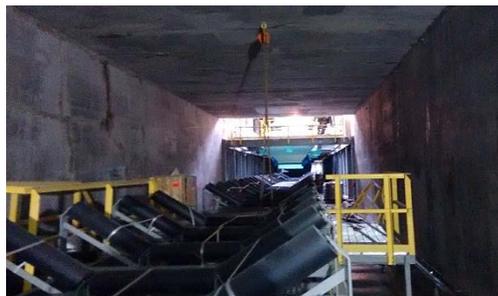
To finish up this repair process, the tech expert went on to recommend that the teams should apply a coat of Krystol T1 over the entire tunnel area instead of on just the repaired areas. Having a continuous layer of Krystol T1 like that would provide the repaired areas with additional Krystol technology protection and give the tunnel itself a barrier against any further water infiltration.

Before going ahead with this application, one of the contractor teams had been concerned that Krystol T1 could impact their tunnel's required sack finish. After consulting with the tech expert and seeing the results for themselves, they found that Krystol T1 did not impact the finish at all. Instead, it completed the Krystol Leak Repair System and kept each tunnel safe and dry enough for the installation of conveyor belts and related equipment, allowing PCT to continue exporting goods and maintaining the livelihoods of the surrounding locals.
