SAB Miller Building Basement

Braamfontein, South Africa

Concrete Waterproofing and
Crack Repair of Concrete Spalling and
Pipe Penetration

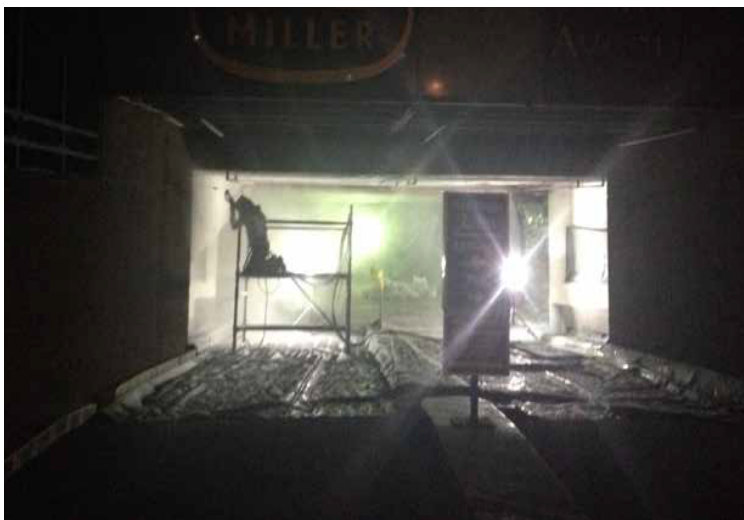
This SAB Miller heritage building in Braamfontein, South Africa had many defects in the existing plaster and concrete basement area and required repair. Because this was a heritage site, any waterproofing and repair would have to be conducted without damaging existing plantation and vegetation on site. Essentially, this meant that only waterproofing systems that could be applied from the negative side of water pressure could be used.

The Krystol Leak Repair was employed to successfully repair and waterproof the reservoir: first, Krystol Plug™, a rapid-setting hydraulic cement product, was used to stop water penetration, following which Krystol Repair Grout™, which is used to resurface defective or deteriorating concrete, was used to stop the concrete from cracking. Lastly, Krystol T1® was used on the surface to transform concrete into a waterproof barrier.
