# Styldrift Mine

Rustenburg, North West, South Africa

**Krytol® Leak Repair System**

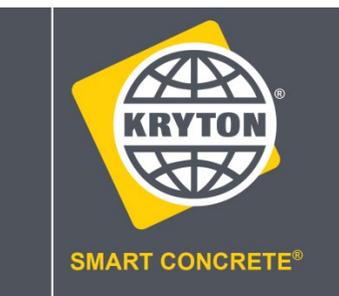
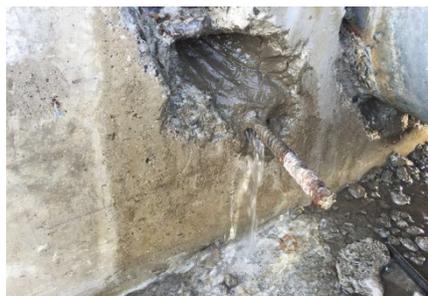
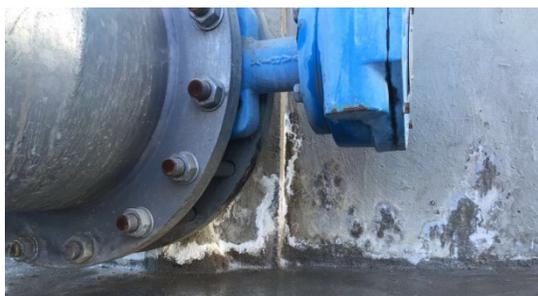
In return, they received an intensive site survey, which provided plenty of insight into the structure's state at the time. The specialists noted that there was excessive movement between the pipe penetration of the structure and the surrounding concrete. And they determined that it was likely the cause for the structure's cracks, spalling, and water ingress.

With that in mind, they successfully applied the system to the exterior wall surface of the container surrounding the pipe penetration and honeycombed area. That gave the concrete Krytol® technology, imbuing it with the ability to react to water chemically to block it out and to self-seal cracks.

In the end, the exterior wall of the water containment structure showed no leaks, satisfying Styldrift Mine that the structure would be able to safely hold water once more.
