High-Speed Rail Tunnel Repair

Guizhou, China (2019)

High-Speed Railway Tunnel Repair

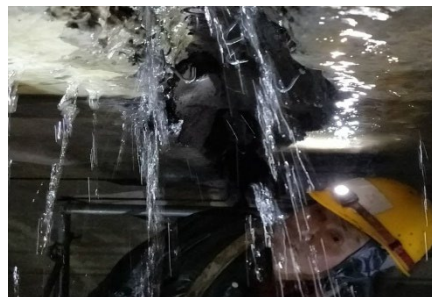
The leak was massive. Its water flow was over 30 L per minute due to the immense pressure created from the 100 m (328.08 ft) of earth above the tunnel.

The first step in this system was to clean up the leaking crack and remove loose concrete and other detritus. Next, grinders were employed to create a groove or chase at the leaking point, shaped for the application of Kryton's Krystol Plug. The plug was then applied, completely stopping the water flow. Krystol Repair Grout was then used to fill the chase flush to the surface of the tunnel wall. After the repair was completed, Krystol T1 was applied to prevent further concrete deterioration and leaks.
