OCEAN CONSTRUCTION, PIPE PLANT BRITISH COLUMBIA, CANADA

**CONCRETE
WATERPROOFING**

PROJECT CASE STUDY

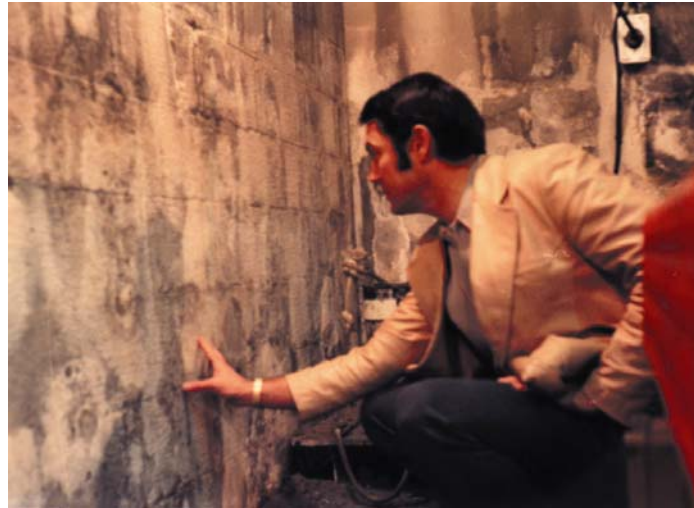
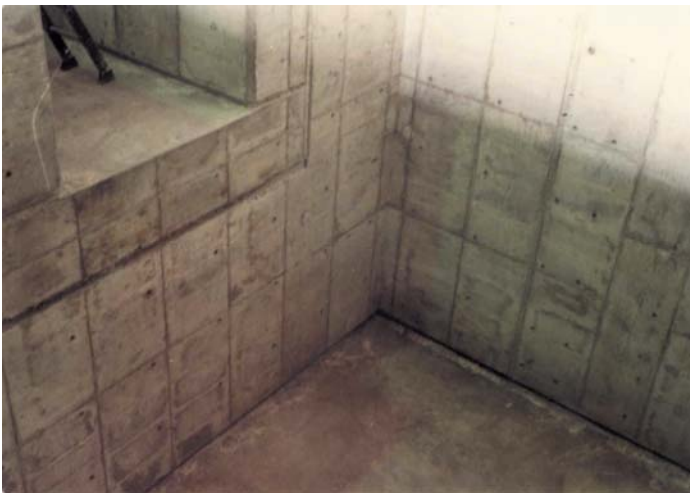
An equipment room, built at the edge of the Fraser River was constructed 17-feet below the water table. Hydrostatic pressure forced water to seep in through the concrete and fill the room with water. On two separate occasions the room was excavated and attempts were made to waterproof from the outside but as soon as the backfill was replaced and pumps removed water returned to fill the room.

Kryton International Inc. undertook the project, guaranteeing 100% success or free labor. KRYSTOL™ T1 and KRYSTOL™ WATERSTOP GROUT were applied to the sealing strips and the walls were coated with KRYSTOL T1 and T2. No further leakage has occurred.
