CAMBIE STREET BRIDGE BRITISH COLUMBIA, CANADA

**CONCRETE
WATERPROOFING**

PROJECT CASE STUDY

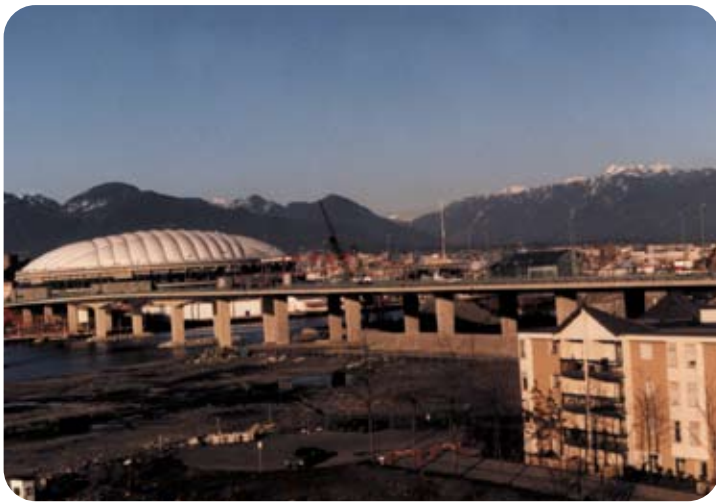
***Krystol™ waterproofing seals
severe deck-slab cracking***

In 1984, Kryton was contracted to provide the materials to repair the leaking cracks. Krystol™ T1 and Krystol™ T2 were applied to the top side of the bridge over the cracked areas. Within 3 days there were no more leaks. To date, the bridge is watertight.

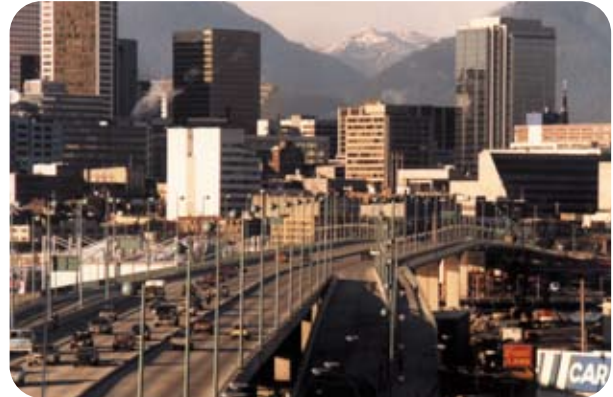
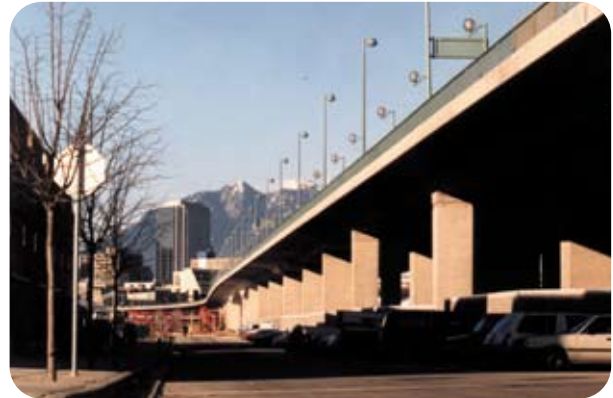
The Cambie Street bridge spans an arm of the Fraser River that separates downtown Vancouver. Shortly after the bridge was constructed, lateral cracks developed full-depth through the deck slab. Extensive water leakage occurred through these cracks during periods of rain. Stopping the water from leaking was a concern for two reasons: the underside marine view of the bridge was important to marine traffic and corrosion control was required by engineers.
