Greenwich Family YMCA

Greenwich, United States (2008)

BACKGROUND

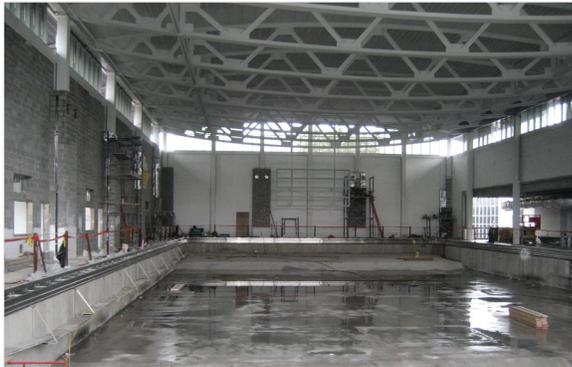
Initially Kryton's Krystol Internal Membrane (KIM) was specified for the new Olympic pool construction by the project consultant. As a cost-saving measure the KIM admixture was eliminated and a lesser jointed detail was employed. This waterstop system failed completely and the structure cracked in several sections under the extreme pressure and weight.

The roughly 850,000 gallon pool was test filled and lost over 120,000 gallons of water in a 24-hour period to the parking deck below. The general contractor called on New England Dry Concrete, a distributor of the Kryton waterproofing system, at the request of the pool consultant to see how they could remedy the situation.

Pool under repair.

New England Dry Concrete performed a total joint repair employing Kryton's crack repair system on the entire wall and joint perimeter. In addition to the crack repair system, another 600 linear feet of cracks were repaired at various locations throughout the pool walls and floor. Sections of the pool were then treated with surface-applied Krystol T1 & T2.

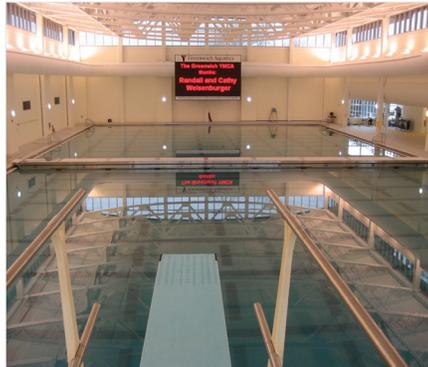
The pool stopped leaking and enabled the project to progress and be completed on time.

Completed pool with no leaks.
