Private Home – Hemingfield Road

Barnsley, England (2012)

BACKGROUND

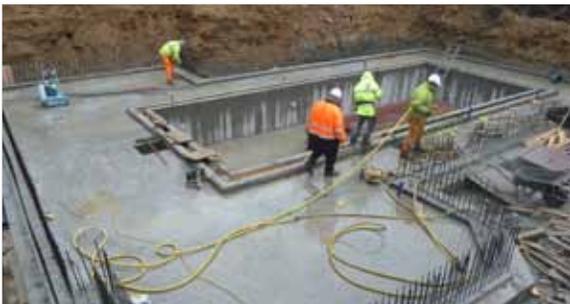
Basement and pool area under construction.

The client also asked that the below grade concrete be poured in three pours to reduce joints and speed up the above grade construction. The three concrete pours included the pool slab, pool walls with basement slab and then the basement walls.

160 cubic meters (209 cubic yards) of concrete in the pool and basement were waterproofed with KIM concrete waterproofing admixture. 100 meters (328 feet) of joints were waterproofed using Kryton's Krystol Waterstop System and 160 tie holes were filled and waterproofed with Krystol Bari-Cote, Kryton's fast-setting waterproof grout.
