# Bloomberg Server Building

New York, USA (2013)

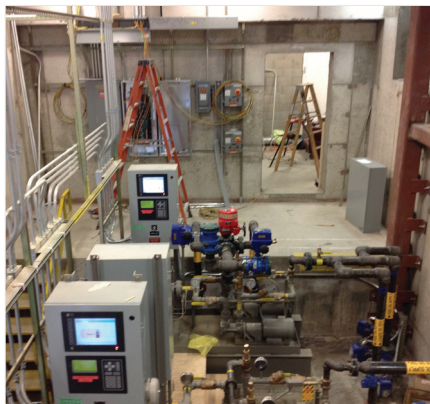
*Construction of the new waterproof concrete walls to house important servers for global transactions.*

The final solution was to surround critical systems with waterproof concrete walls incorporating Kryton's Krystol Internal Membrane (KIM) concrete waterproofing admixture. In addition, the concrete-to-concrete joints of the walls were constructed using Kryton's Krystol Waterstop System to fully tank the room. To provide extra protection, Krystol T1 & T2 Waterproofing System was applied to the outside of the walls.
