Futang Tunnel/Ying Wen Highway

Sichuan, China (2014)

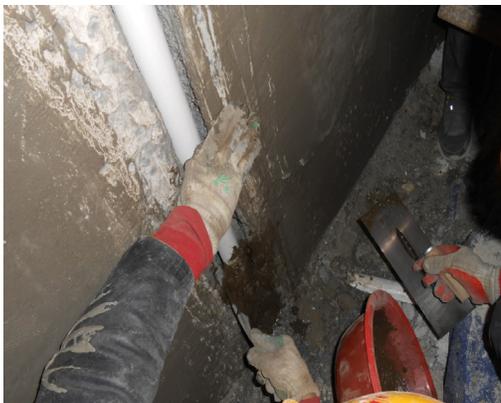
The construction team filling one of the many cracks of leaking water.

Kryton's crack repair system was called in to do the job correctly, permanently fixing the damage caused by the mudslide. After the cracks were assessed, Krystol Plug was used to stop the flow of water, followed by Krystol T1 and then Krystol Bari-Cote. To finish, a coating of Krystol T1 was used to ensure a watertight seal for a permanent solution to the leaking problem in the Futang Tunnel.

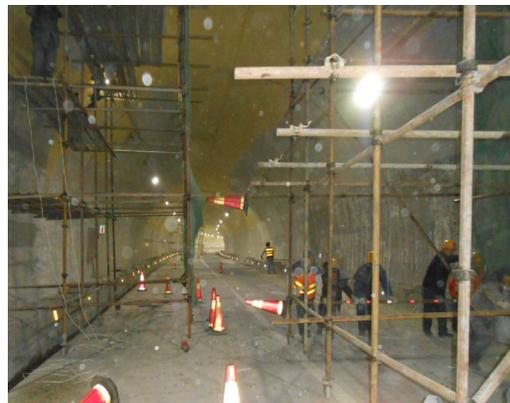
The construction crew used Krystol T1®, Krystol Plug™ and Krystol Bari-Cote™ to repair the massive leaking left by the mudslide.
